## THE PERCEPTION OF CATASTROPHIC FLOODS IN THE NEMUNAS RIVER BASIN

D. MEILUTYTĖ-LUKAUSKIENĖ, V. AKSTINAS, D. ŠARAUSKIENĖ, J. KRIAUCIŪNIENĖ  
LITHUANIAN ENERGY INSTITUTE, LITHUANIA

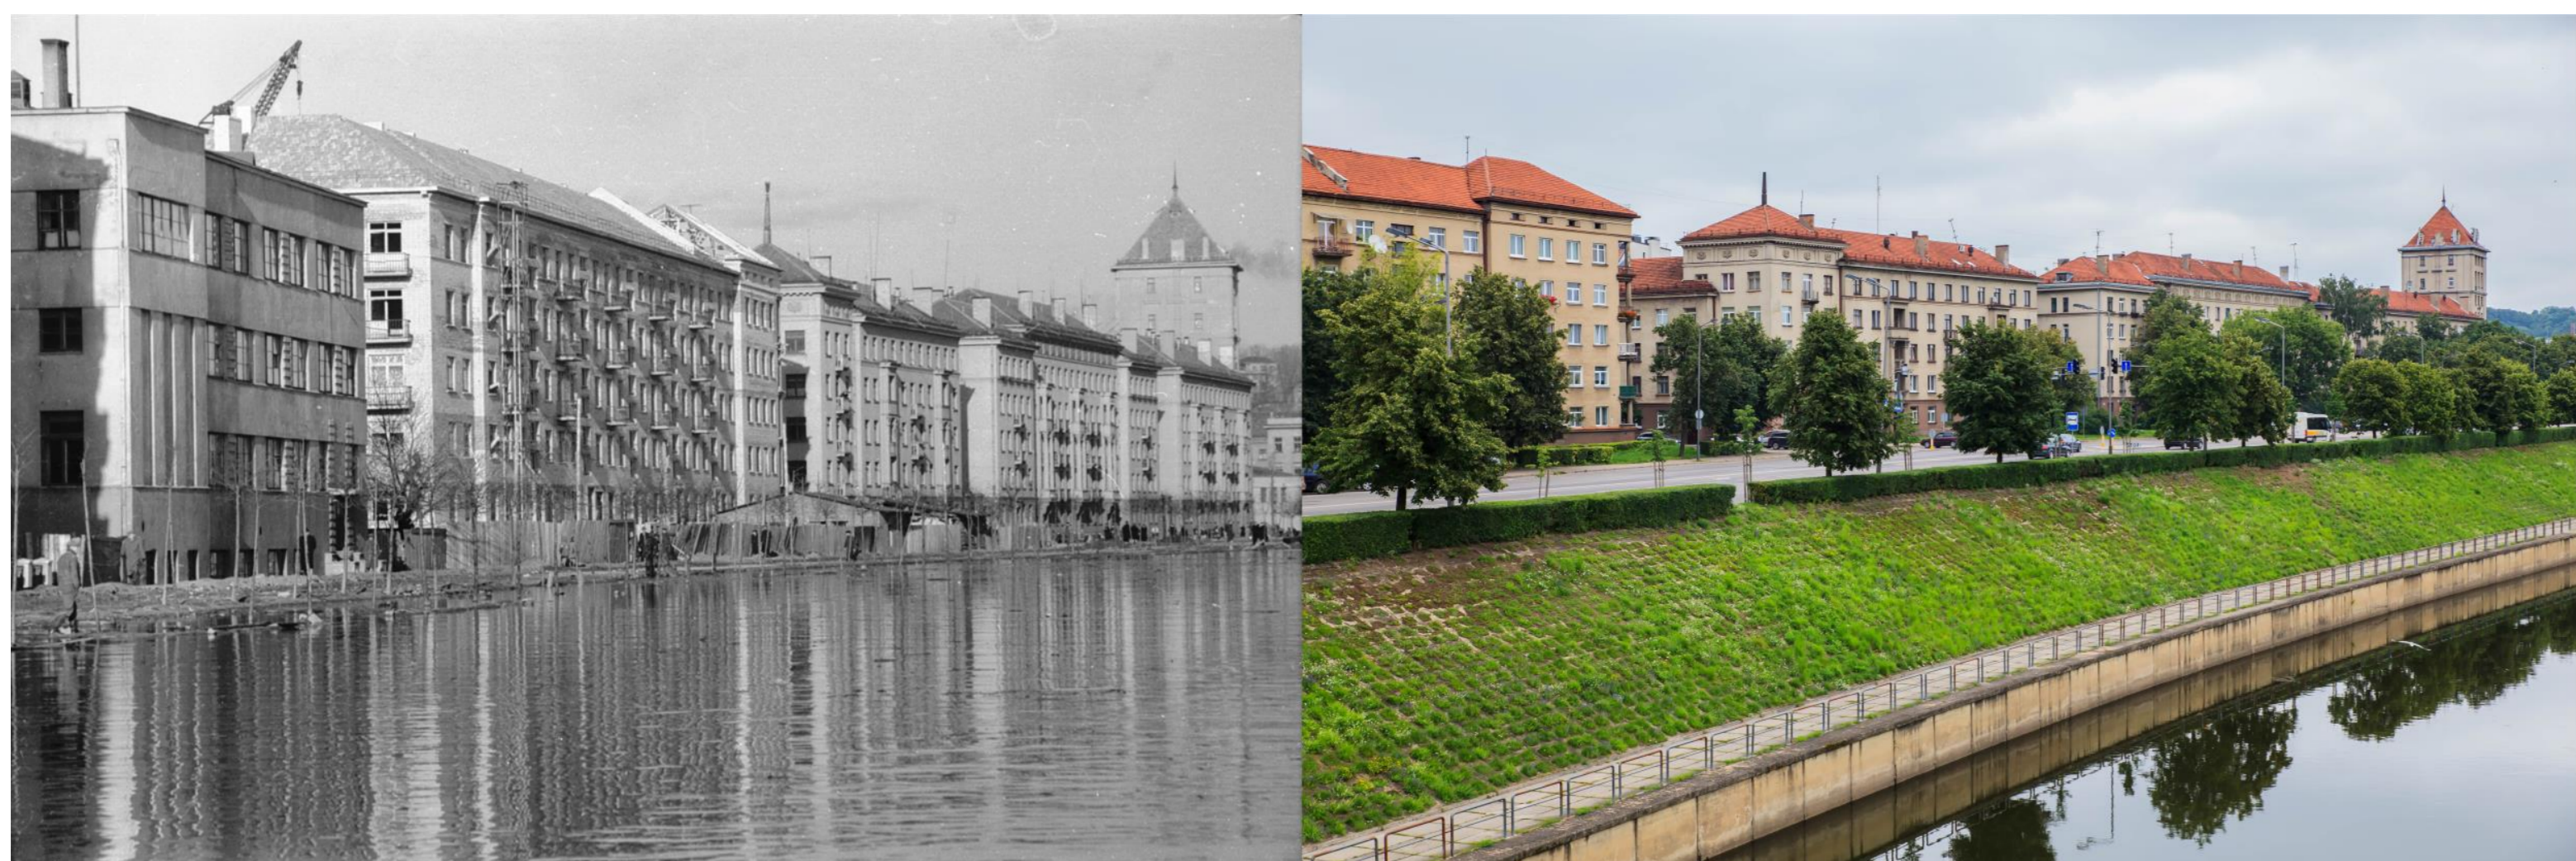
Comparison of Kaunas (Lithuania) street view during the flood of 1958 (left) (photo by Stanislovas Lukošius, Kaunas city Museum Collection) with close to annual average water level in 2017 (right) (photo by Vytautas Akstinas)

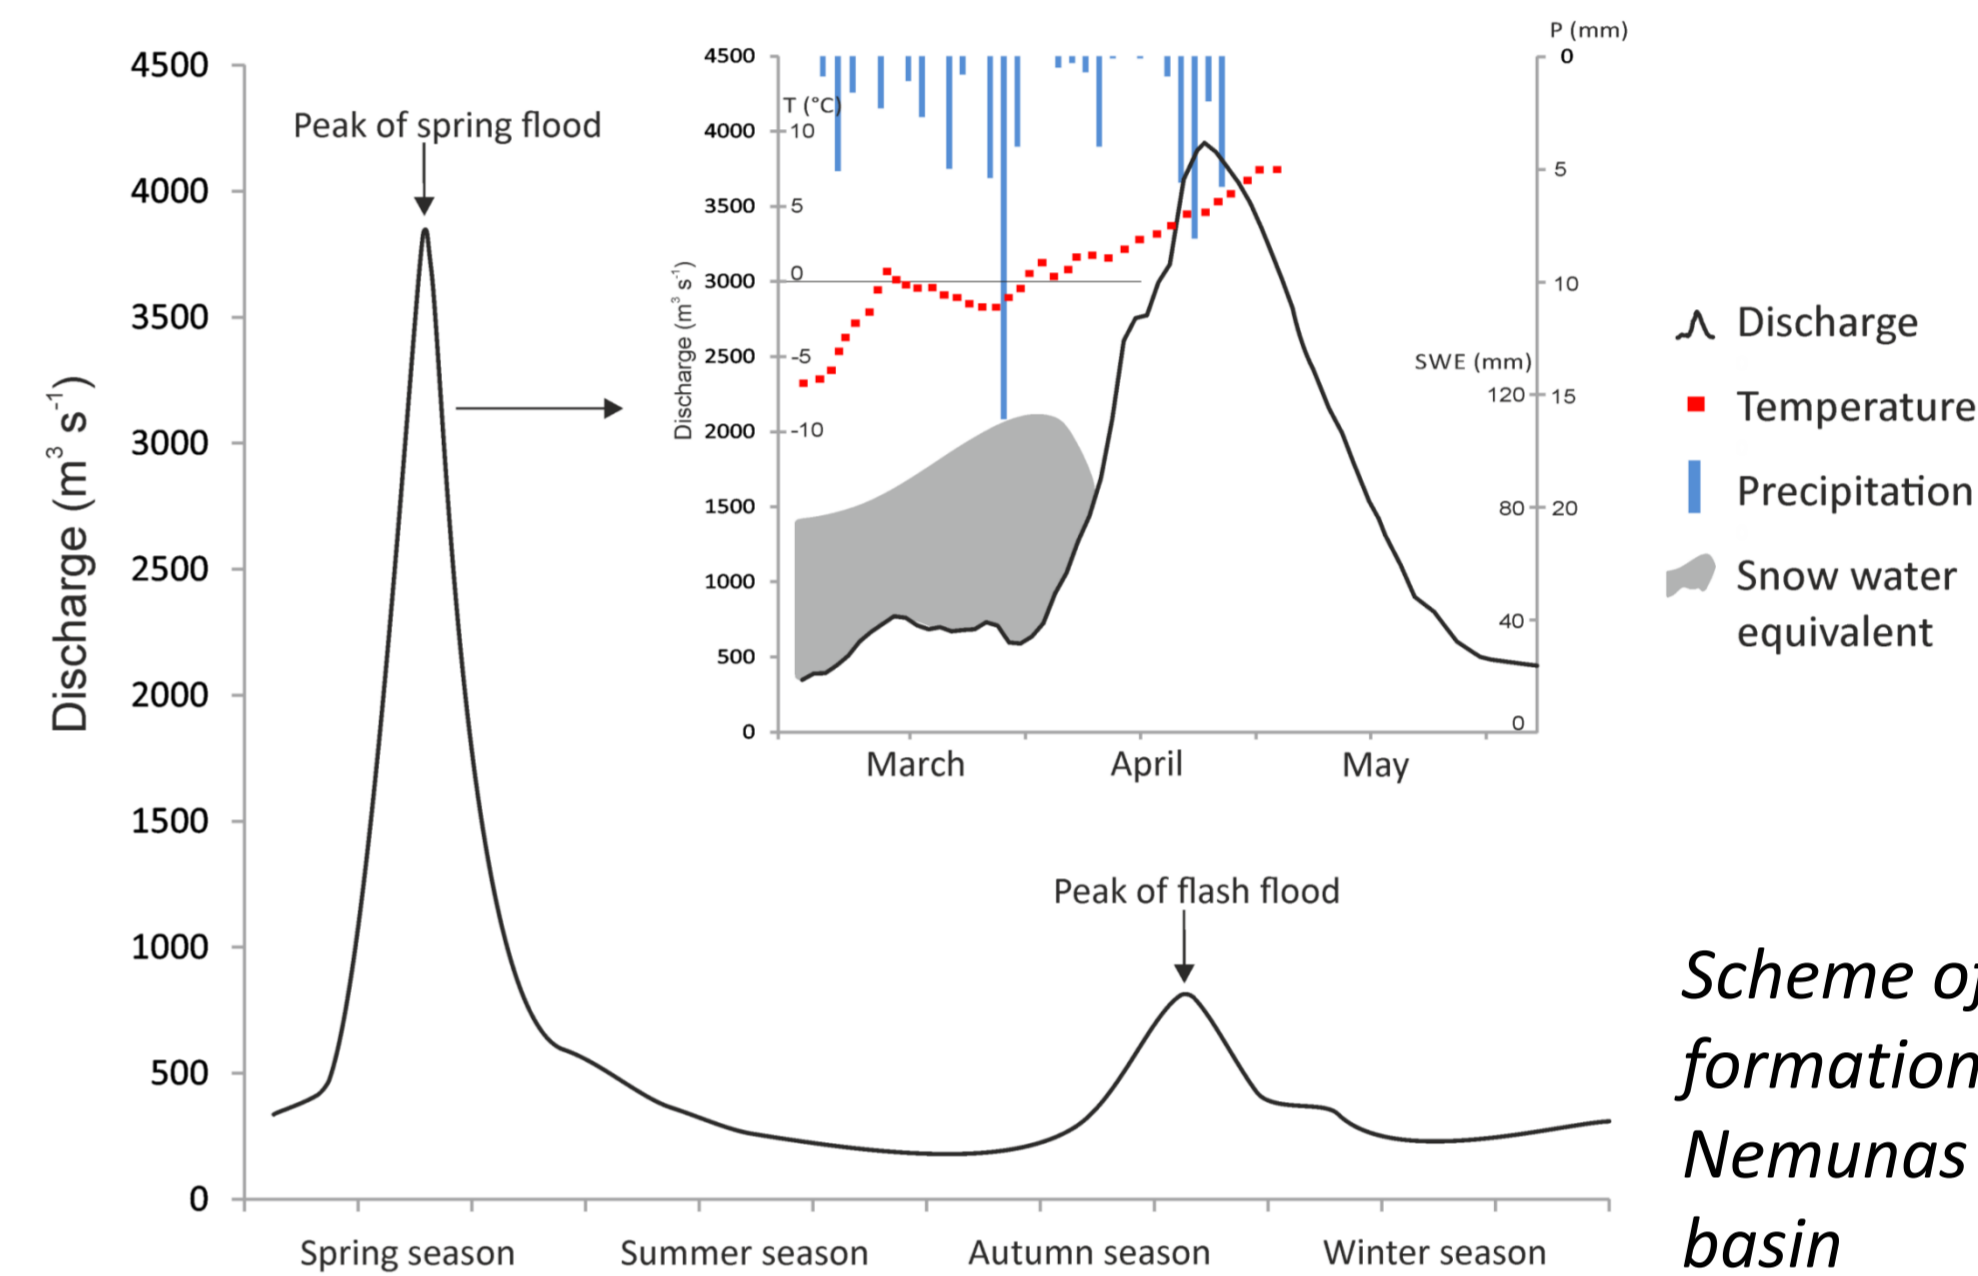
Scheme of flood formation in the Nemunas River basin
