KARST DENUDATION INTENSITY AND CLIMATE CHANGE. THE CASE OF THE NORTH LITHUANIA

Taminskas, Julius¹, Mikulėnas, Vidas², Simonas, Danielius^{1,2}, Satkūnas, Jonas^{1,2} and Minkevičius, Vytautas^{1,2}

¹Nature Research Centre, Akademijos str. 2, 08412 Vilnius, Lithuania

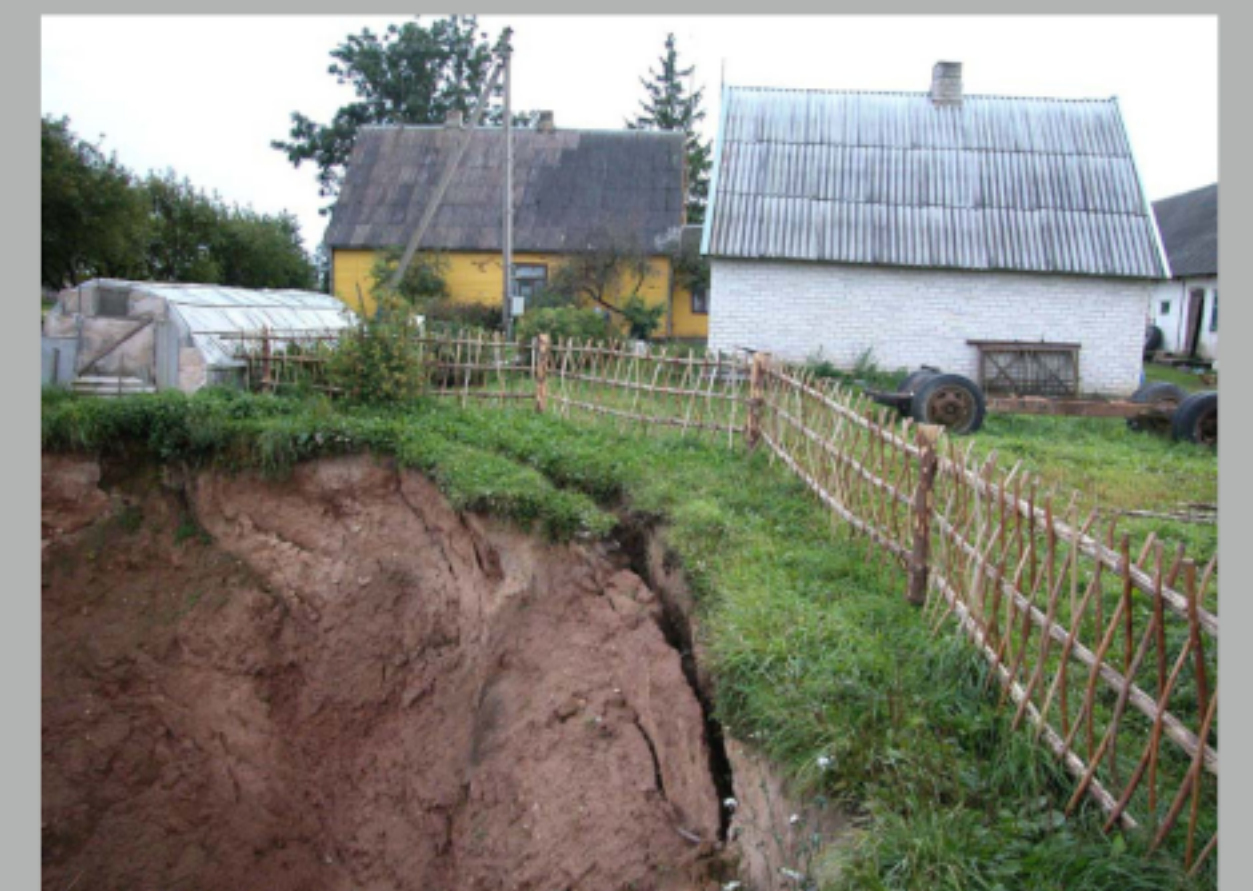
Karstic collapse sinkhole in Daumėnai. V. Mikulėnas, 2005

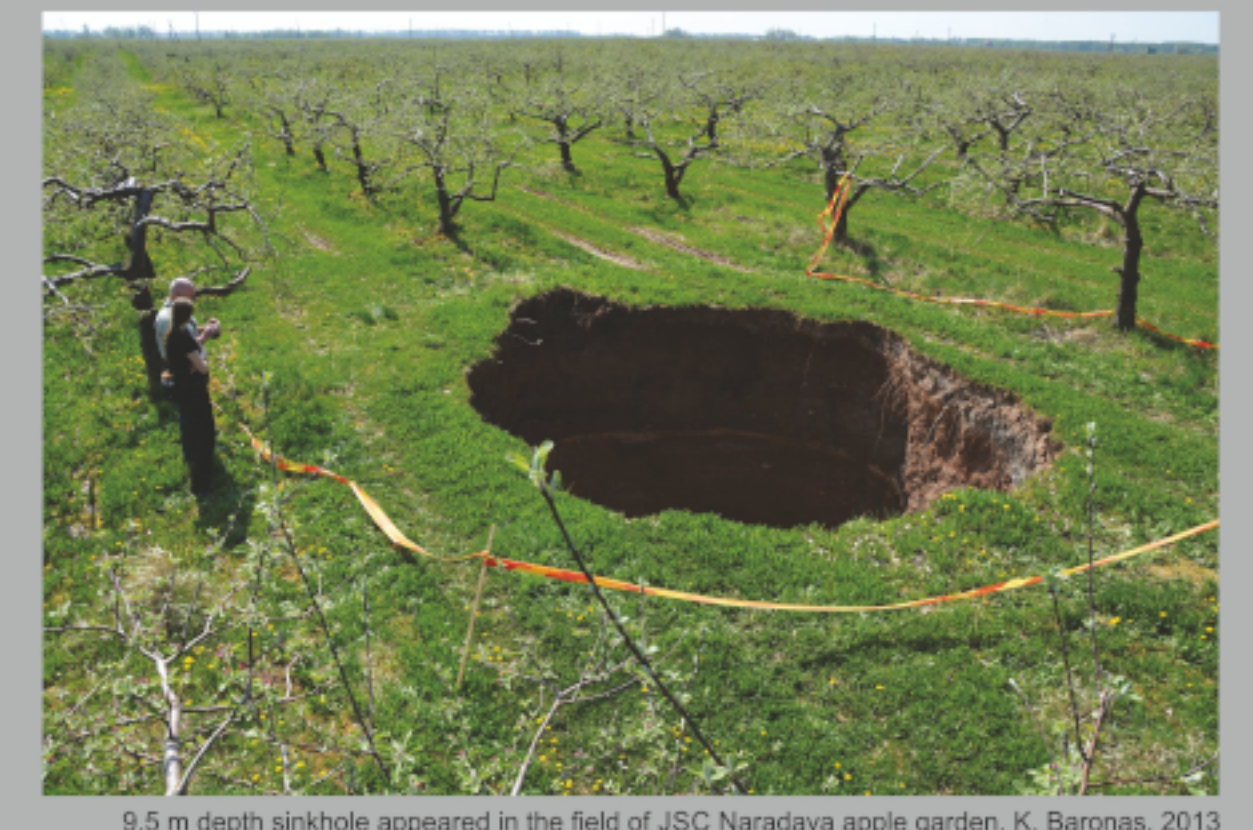
9.5 m depth sinkhole appeared in the field of JSC Naradava apple garden. K. Baronas, 2013

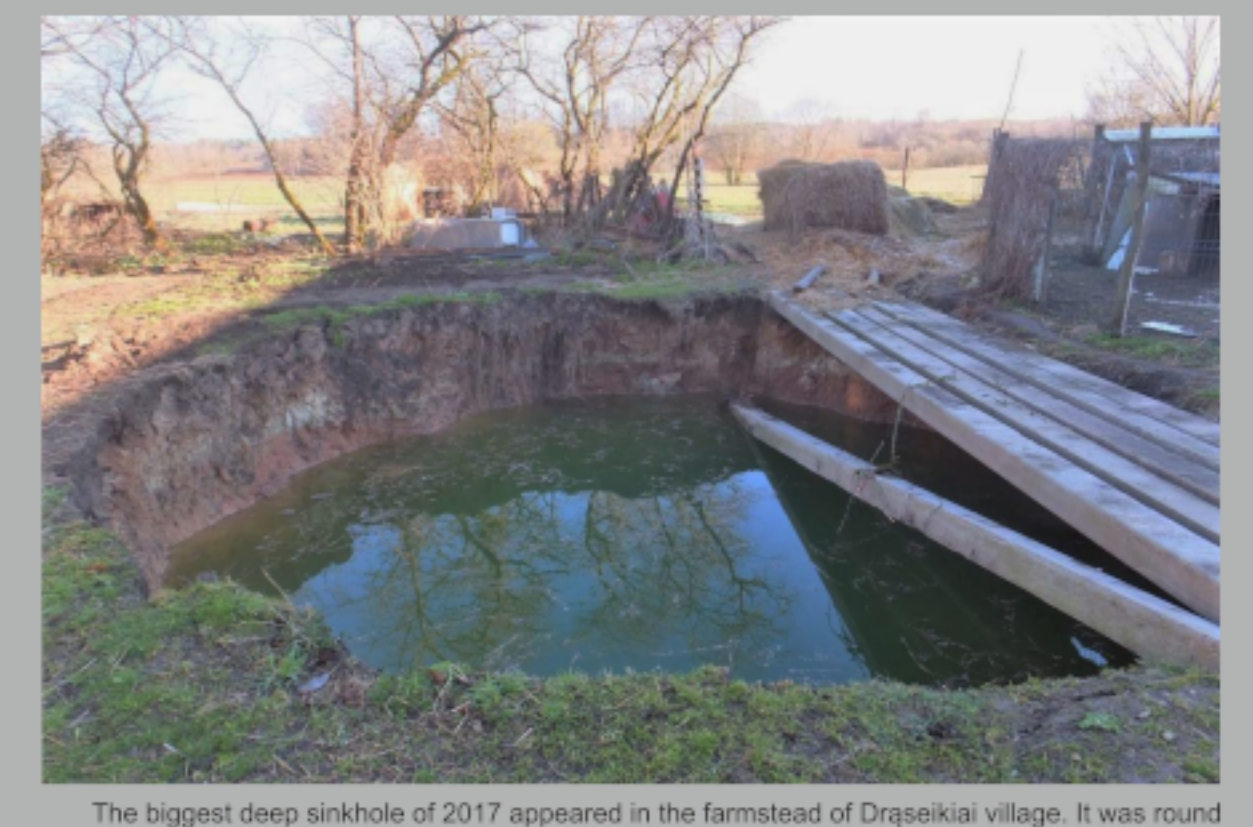
The biggest deep sinkhole of 2017 appeared in the farmstead of Drąseikiai village. It was round shaped, 7.5 m in diameter and reached 2.1 m depth, 2/3 filled with water. B. Dagys, 2017
